Claude MONET - La berge de Lavacourt sous la neige

Condition Report

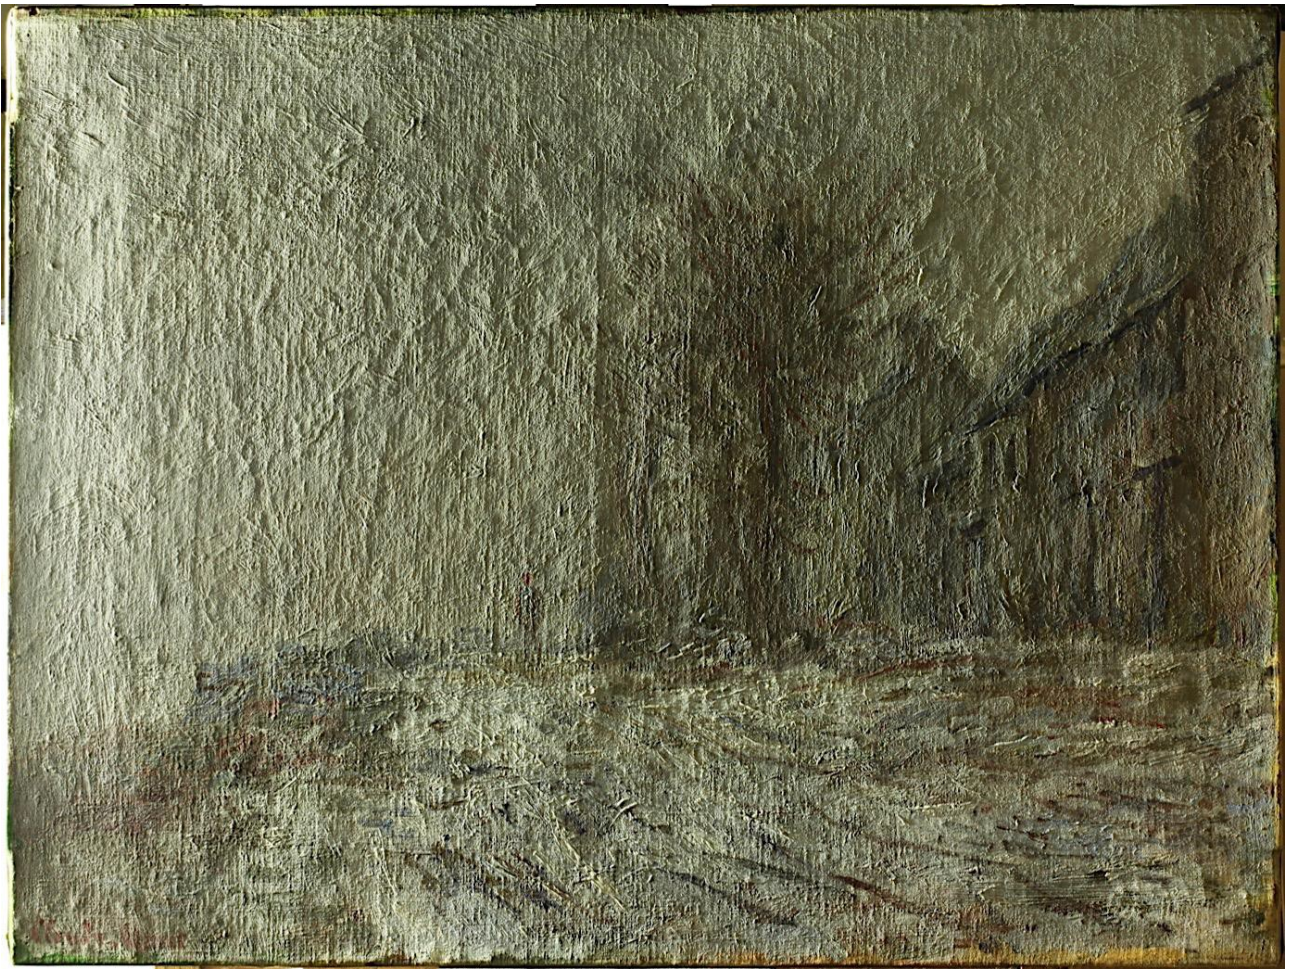
The canvas tension and the overall homogeneity of the surface are satisfying apart from a some very light undulation and a barely visible mark of the stretcher's joint (Fig. 3); the stretchers have been considerably opened in the past in order to re-stretch the canvas, consequently leading to the irregularities at the extreme upper and lower parts of the two lateral edges (Fig. 3).

Fig. 3: Overall view under raking light.

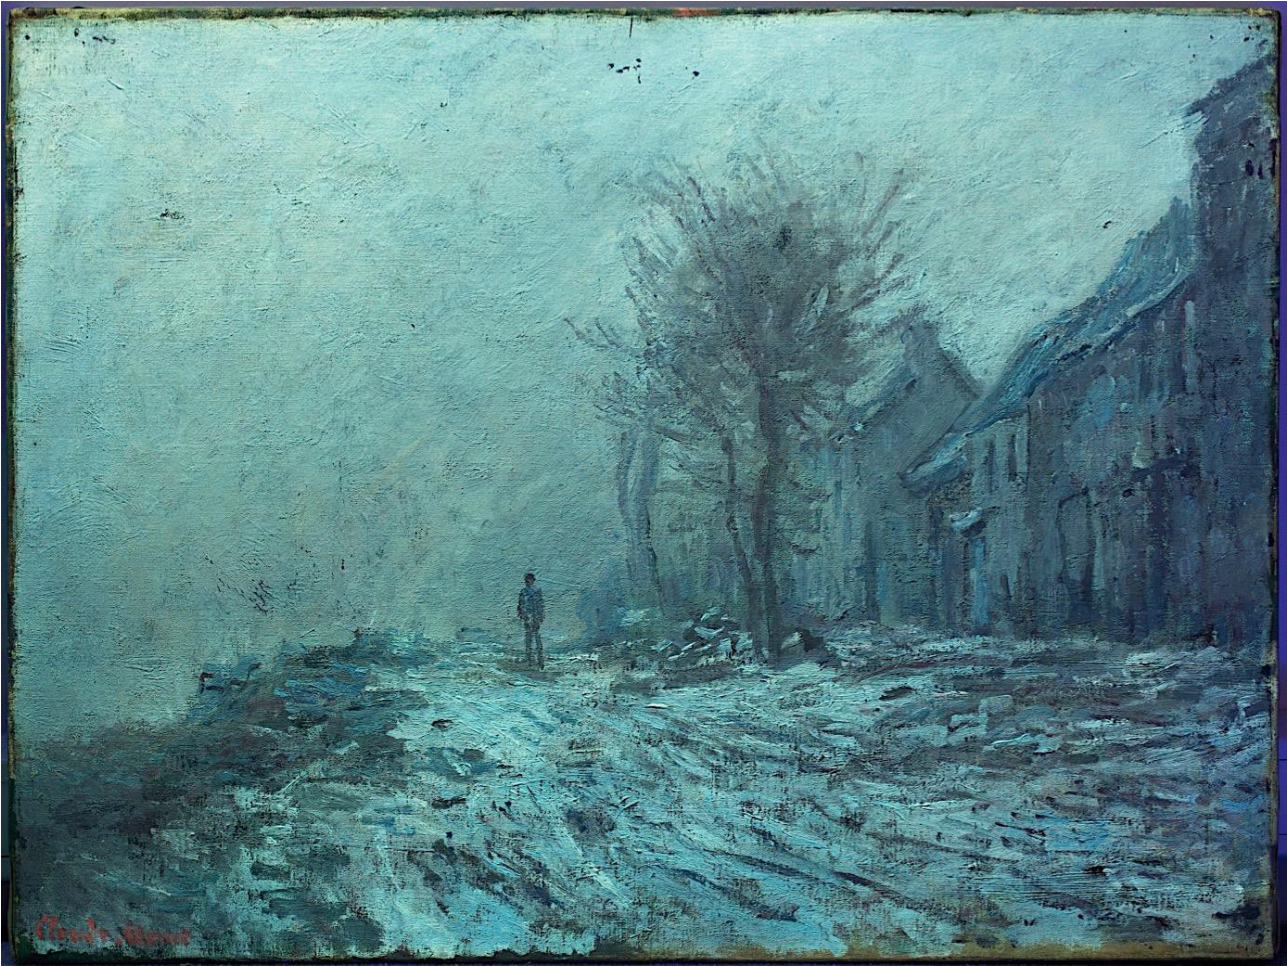
When examined under ultra-violet light, the underlying composition fluoresces relatively darker (Fig. 4). Most of the fluorescing dark spots visible under ultraviolet light correspond to areas of the underlying composition showing through, and hence are not damages. There are a few further sparse spots or lines of retouching along some of the craquelure (Fig. 9).

Fig. 4: Overall view under ultraviolet light.

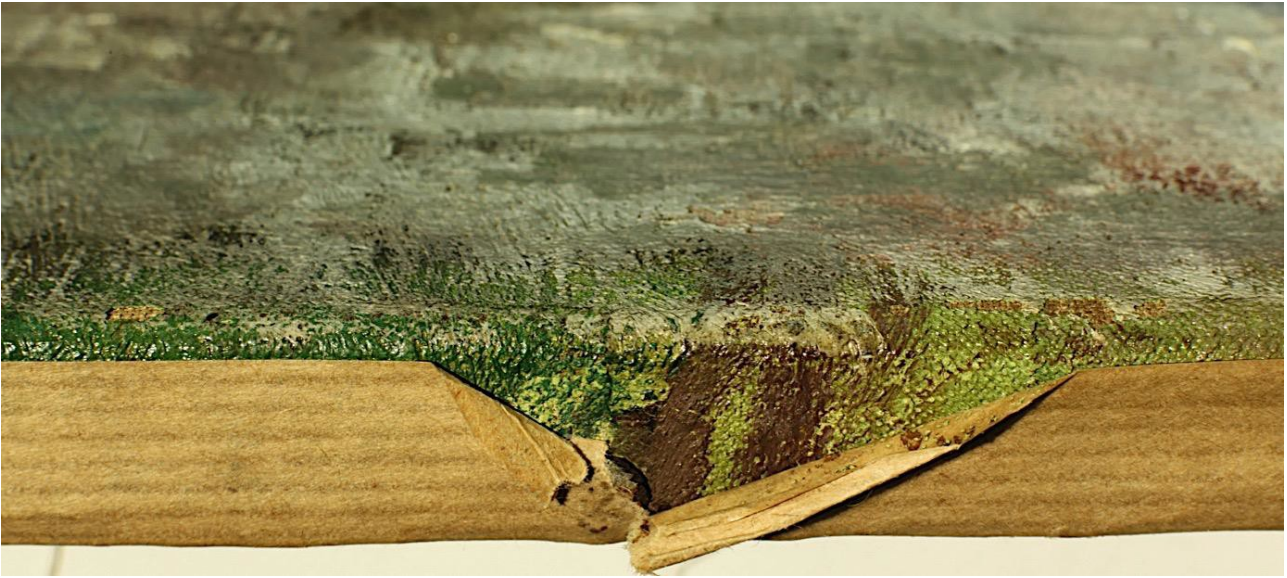
The artist painted over a canvas he had already painted, as hinted by the presence of an underlying composition, predominantly green in color tone (most likely a landscape), which is visible in several places along the edges and which is present throughout the surface (Fig. 5, 6a, 7a & 8a). He nailed his canvas on a stretcher of a smaller size, close to that of a no. 20 landscape format, trimming the excess of canvas before covering it with the present composition. The pictorial surface is thick and concealing, almost entirely covering the underlying composition. In the four angles, there are a few original pinholes that correspond to the artist's use of separating brackets in order to isolate the canvas when the painting was still wet (Fig. 6a et 8 a).

Fig. 5: Detail of the lower left edge; underlying composition.

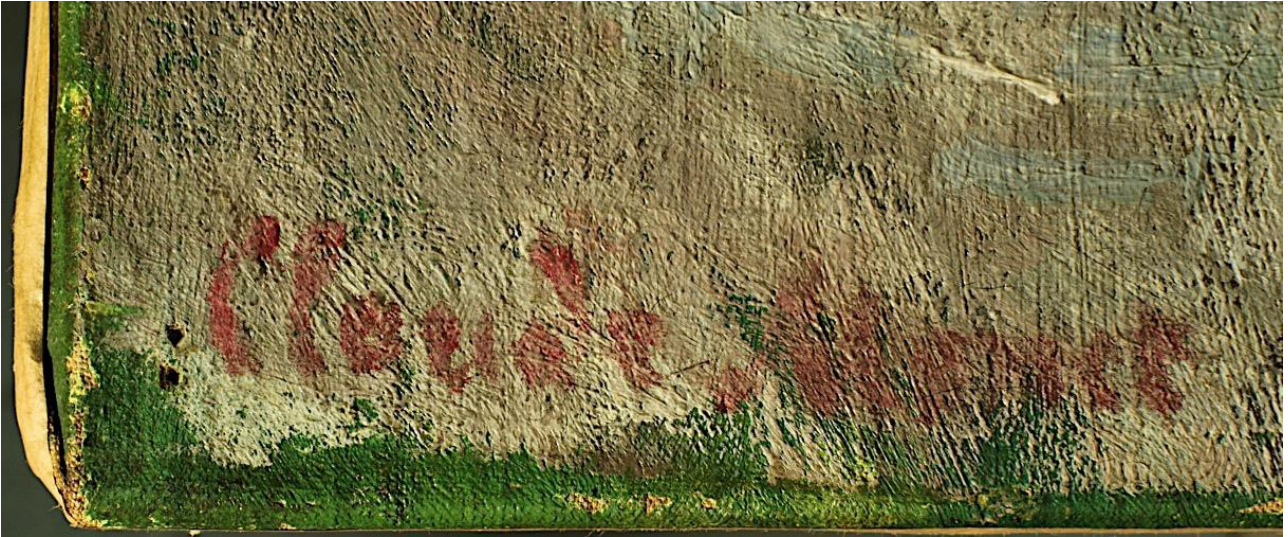
Fig. 6a: Signature, with the artist's pin holes on the left.

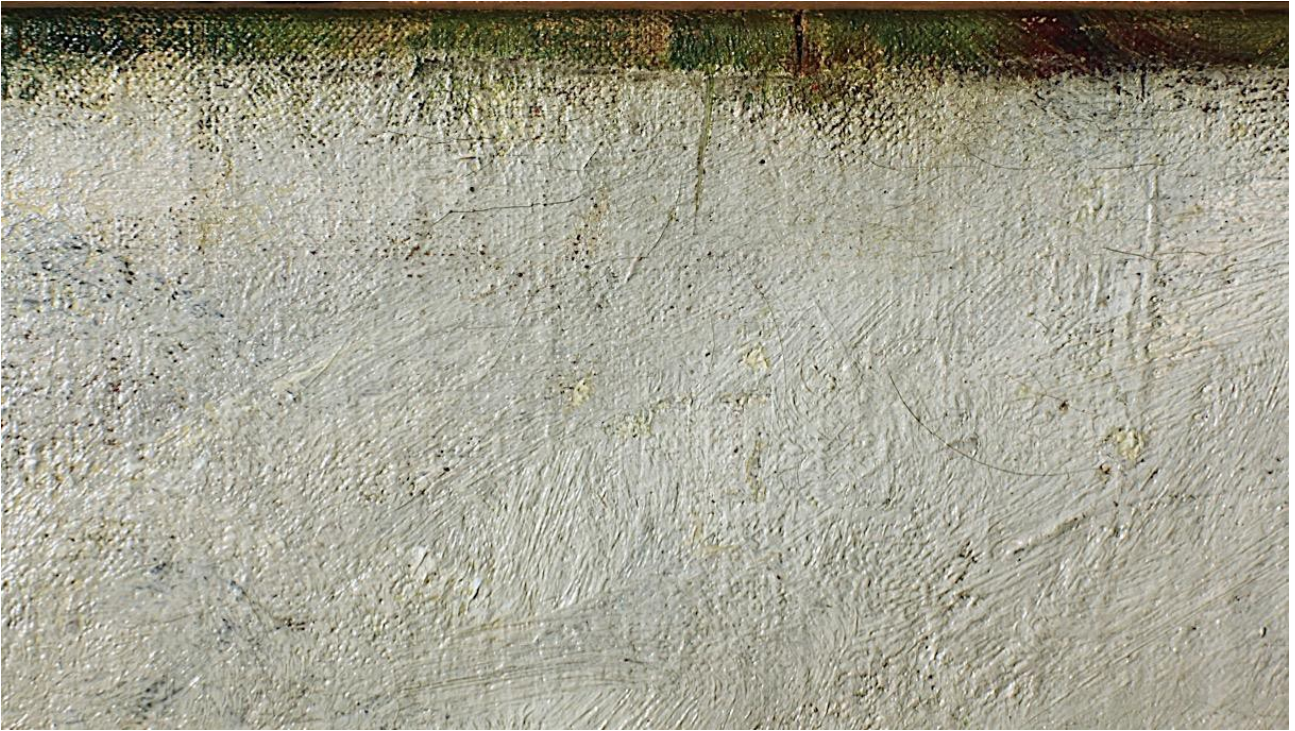
The borders are covered with brown paper tape that does not cover the surface on the front. There appears to be two small paint losses outside the painted surface, located towards the upper left corner and towards the lower right corner, and small dent at the center of the upper edge (Fig. 7a).

There appears to be a few paint losses that reveal the canvas, predominantly located on the tip of the right edge, most likely resulting from the rubbing of a frame, as well as a small scratch at the center of the upper edge (Fig. 7a & 7b). A network of craquelure resulting from the painting's aging is present in the pictorial surface, some are wider than others such as the ones on the left in the center (Fig. 9).

Fig. 7a: Detail of the center of the upper edge.

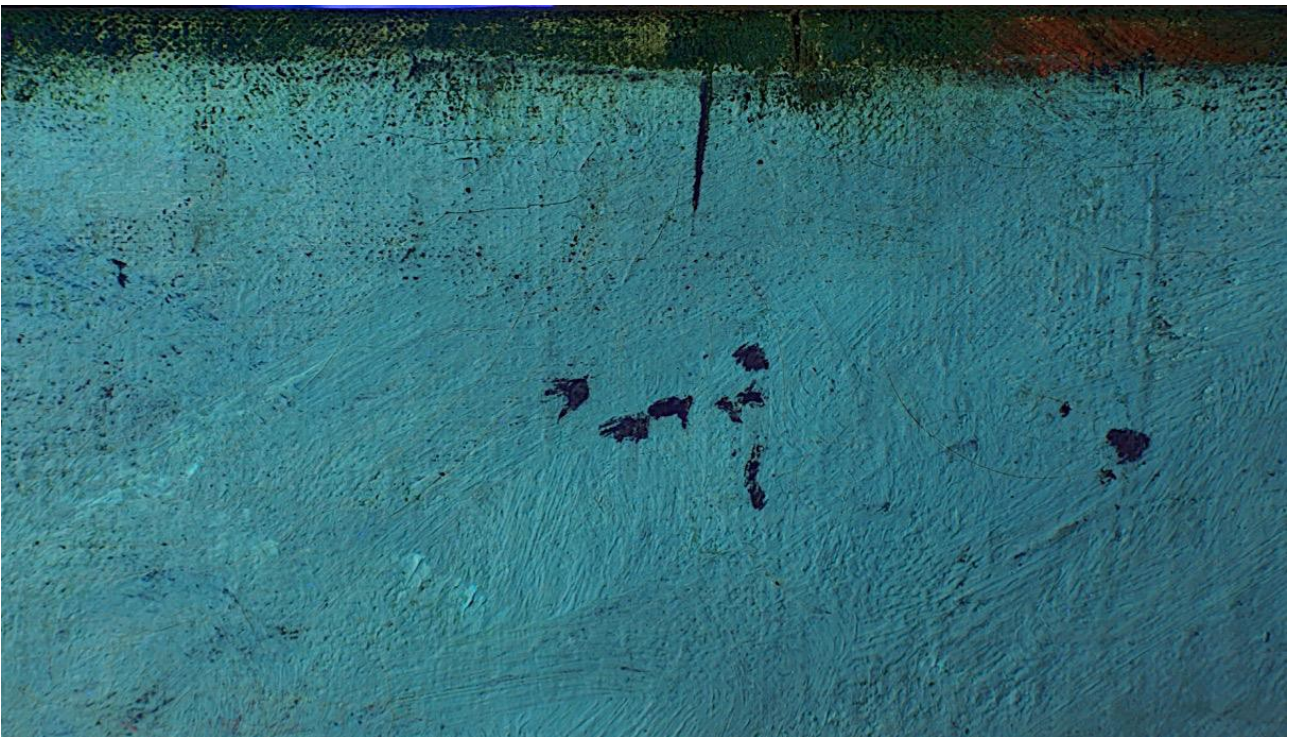
Fig. 7b: Detail of the center of the upper edge under ultraviolet light.

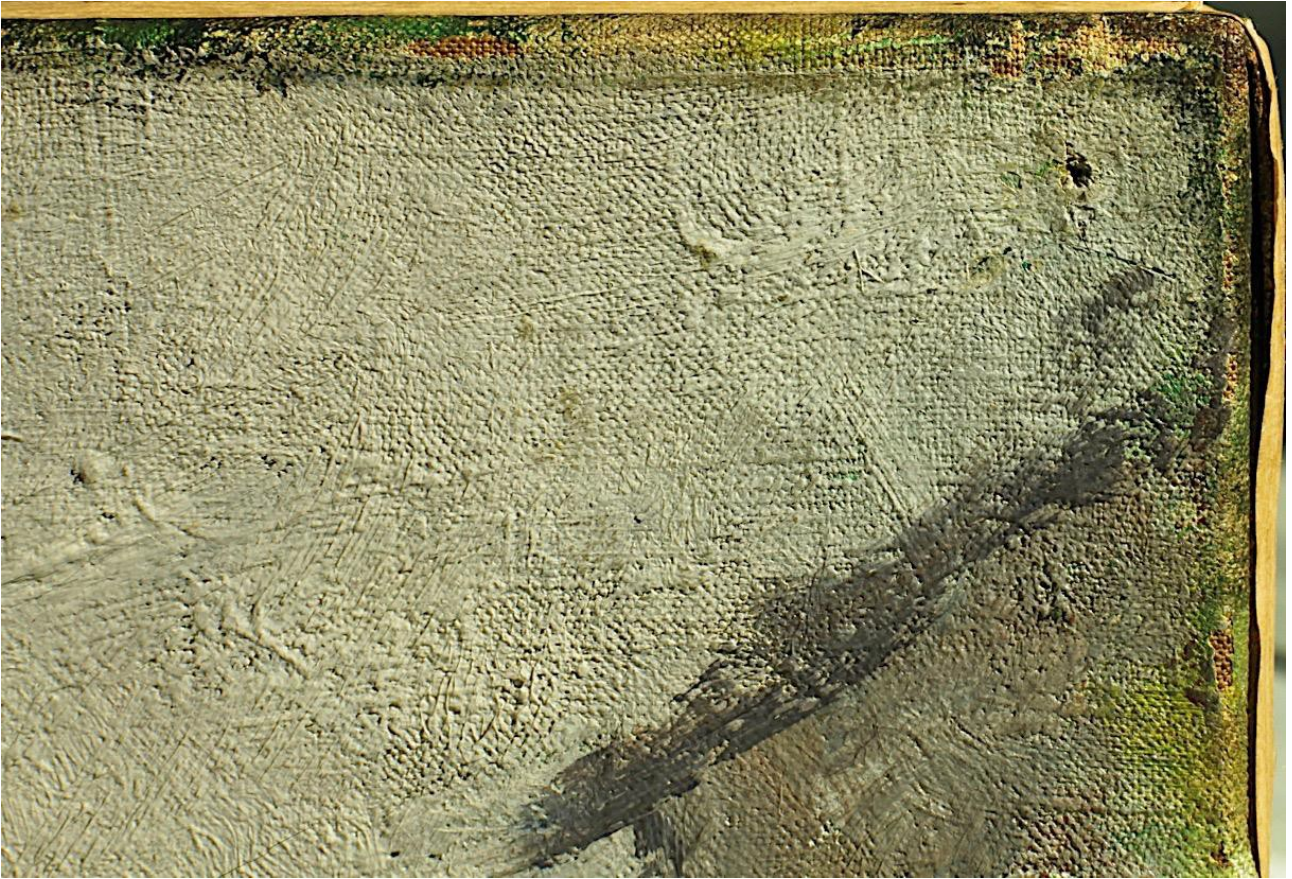
Fig. 8a: Detail of the upper right corner with the artist's pin holes.

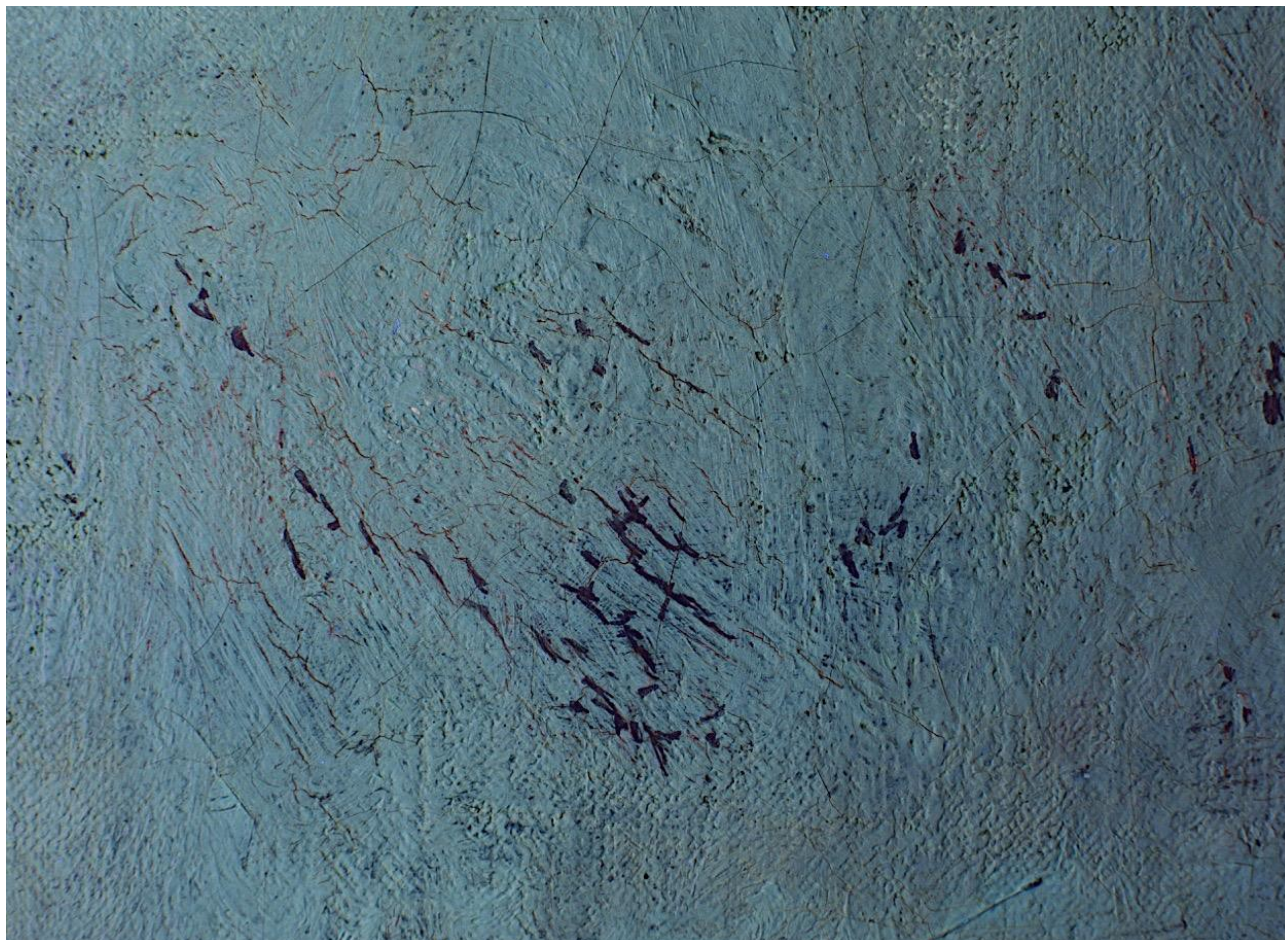
Fig. 9: Detail under ultraviolet light, half way on the left : small spots of retouching in the craquelure.
