Claude MONET - La berge de Lavacourt sous la neige

Condition Report

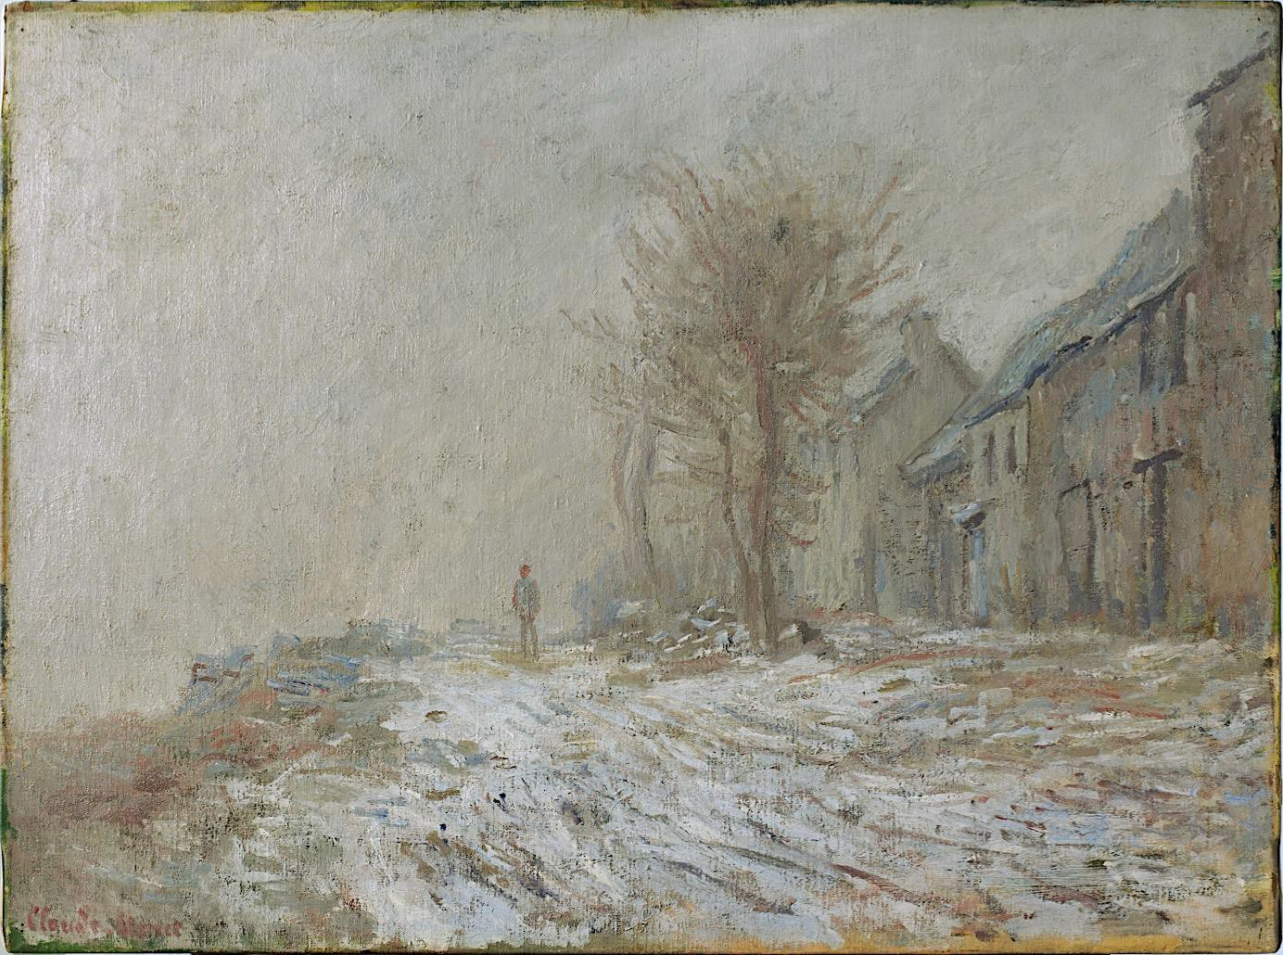
The painting is overall in very good condition.

Fig. 1: *La berge de Lavacourt sous la neige*, overall view.

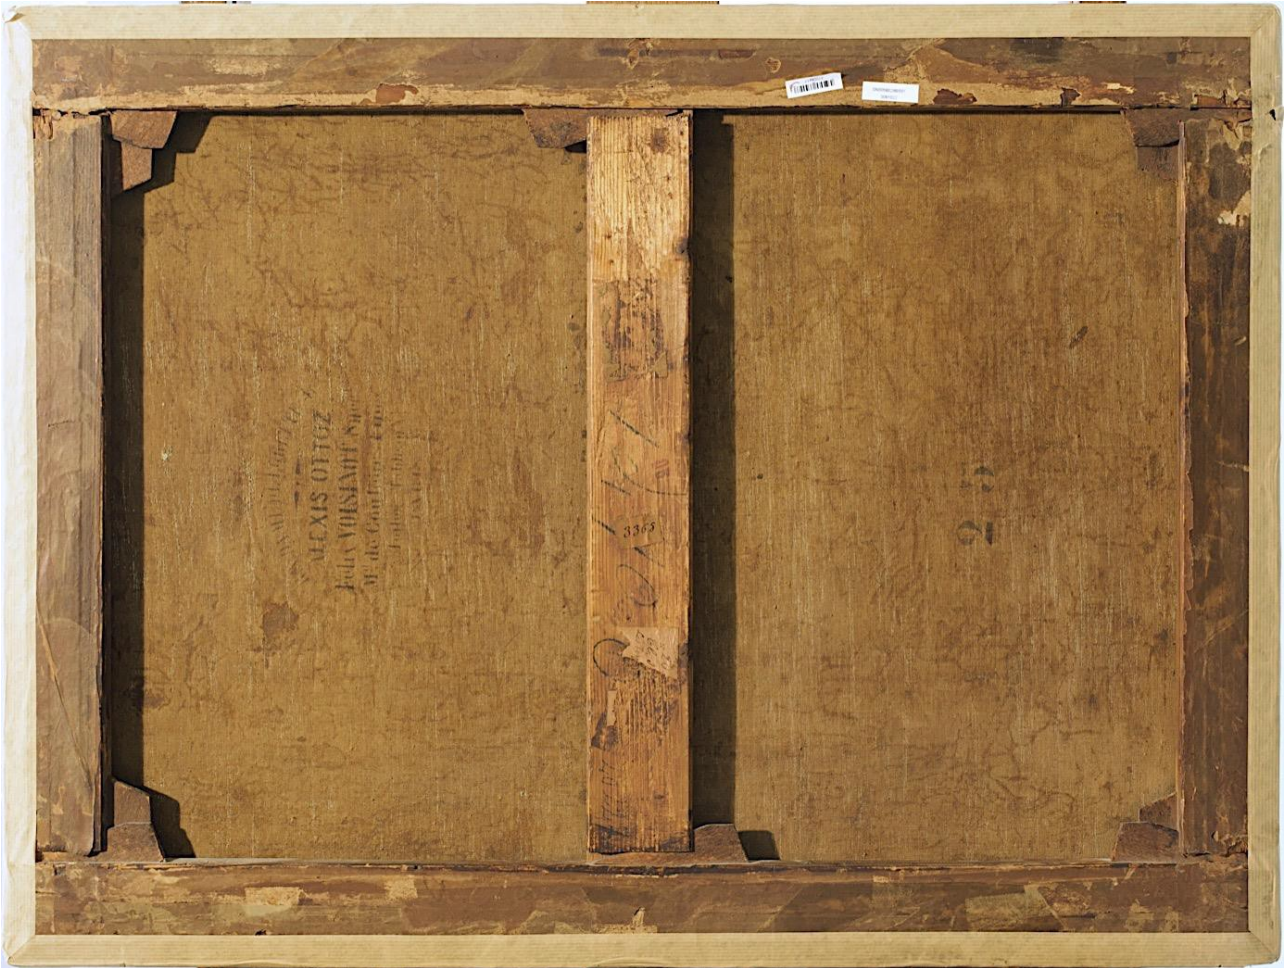
The painting was executed on a very fine canvas (20-21 x 23 threads per cm²), it was coated with an off-white ground (which is barely visible except in a few sparse areas along the edges). The canvas weaving is slightly open in the direction of the threads, occasionally letting the oily ground come through, which has formed a few drops on the reverse of the canvas (Fig. 2). The canvas was produced by the Parisian canvas maker Voisinot, Ottoz' successor, and was sold as being originally stretched on a stretcher larger than the current one, size no. 25 (approx. 81 x 65 cm).

Fig. 2: Overall view of the reverse, with the canvas maker's stamp Voisinot, Paris; on the right, with the stamp indicating the size '25'.

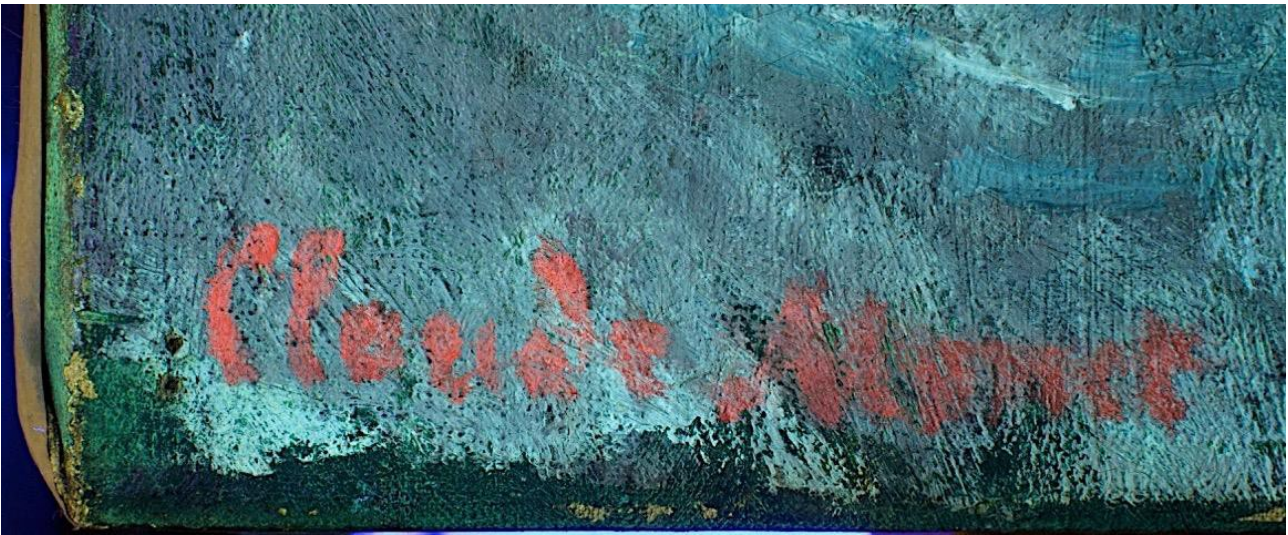
The artist painted over a canvas he had already painted, as hinted by the presence of an underlying composition, predominantly green in color tone (most likely a landscape), which is visible in several places along the edges and which is present throughout the surface (Fig. 5, 6a, 7a & 8a). He nailed his canvas on a stretcher of a smaller size, close to that of a no. 20 landscape format, trimming the excess of canvas before covering it with the present composition. The pictorial surface is thick and concealing, almost entirely covering the underlying composition. In the four angles, there are a few original pinholes that correspond to the artist's use of separating brackets in order to isolate the canvas when the painting was still wet (Fig. 6a et 8 a).

Fig. 6b: Signature, with the artist's pin holes under ultraviolet light.

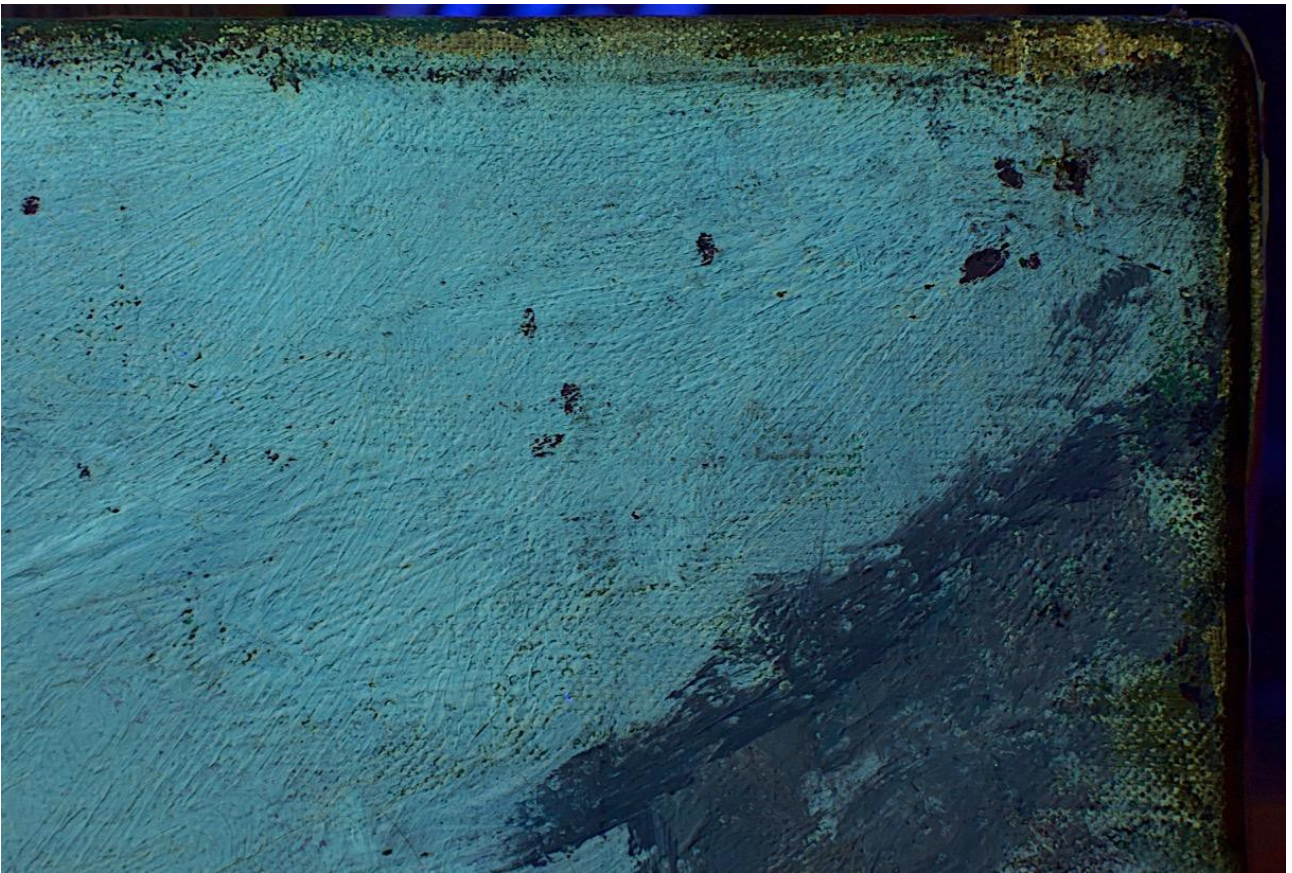
Fig. 8b: Detail of the upper right corner with the artist's pin holes under ultraviolet light.
